SERVICE MANUAL

Addo-X SERIE 40

S E R V I C E M A N U A L A D D O - X

40 SERIES

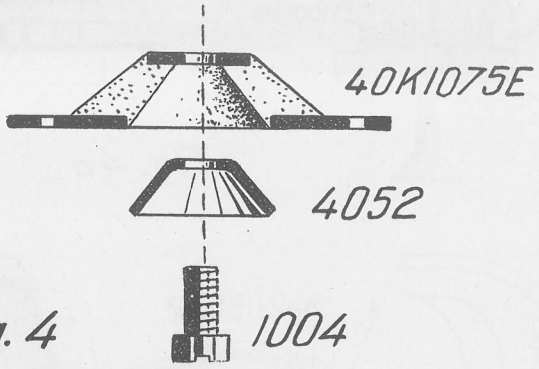
Fig. 4

2. In order to avoid exaggerated vibrations on the dampers [40K1075E], a new part is used, namely Damper Cone 4052. This part is placed as per Fig. 4.

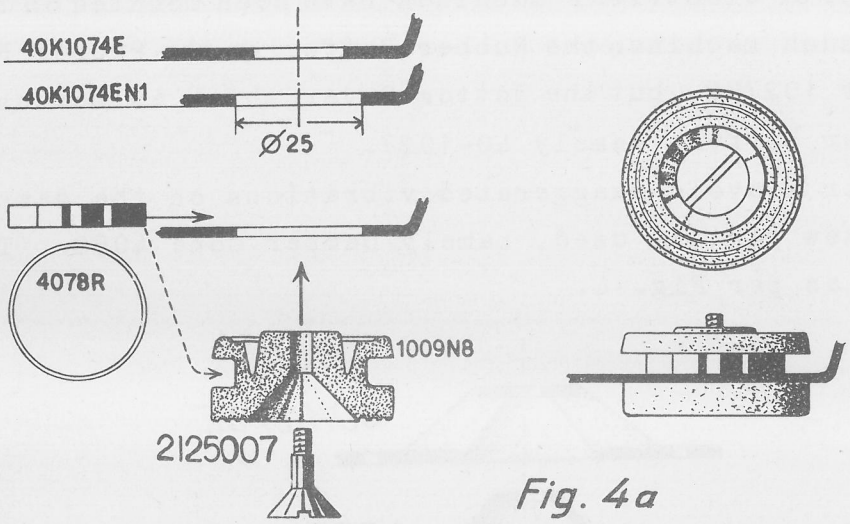
The new rubber feet can be used as replacement for the old dampers and feet if the hole for screw 1004, formerly used, is enlarged to Ø 25 and a Ring 4078R is installed as per Fig. 4a [see back of this page]. The rear feet [with felt] remain on the bottom cover but the fore ones are to be removed.

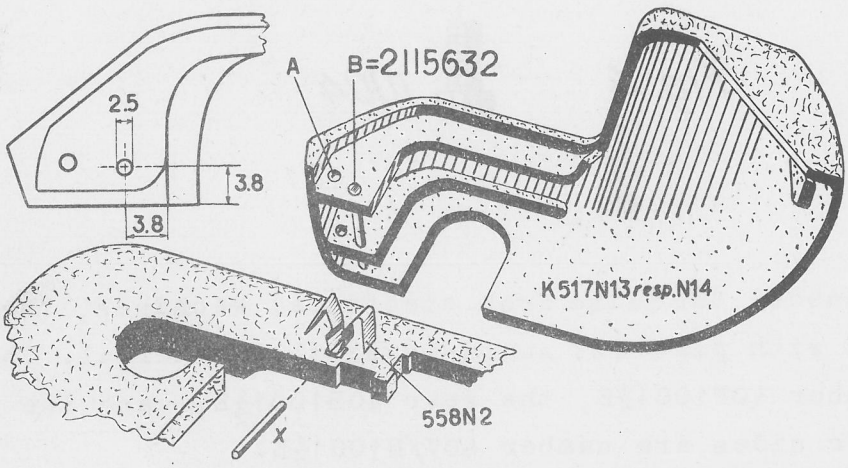
Fig. 4b

A new Spring 558N2 for attaching the ribbon spool covers K517N13, -N14 has been designed. This spring can also replace Spring 558 on old machines. It is fixed in the square hole of the cover by means of Taper Pin X, Fig. 4b. [X is for Hand Machines 2112002, and for El. Machines 2112003].

When using the Spring 558N2 for replacing the 558 it will be necessary to bore the holes B as per Fig. 4 b and fasten the Pin 559 in the ribbon spool covers.

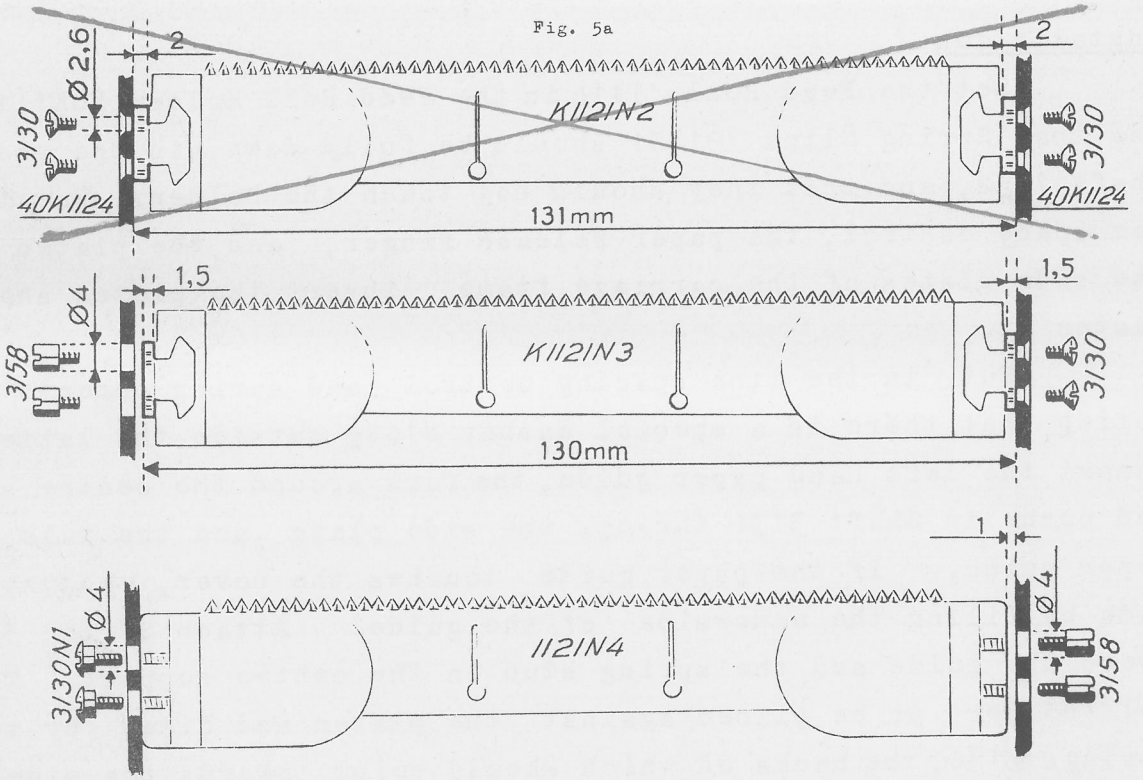
The fixing brackets of Paper Knife K1124 have been modified so that the knife can now expand and contract in different temperatures. The modification will be evident from Fig. 5a (April 1952).

Paper Knife 1121N4 was introduced in December 1952. It is fixed in the left carriage end and moves freely on the right side in order to keep a determined distance to the platen ratchet wheel. N4 can replace both N3 and N2 if the fixing holes of the carriage frame are made ø 4.

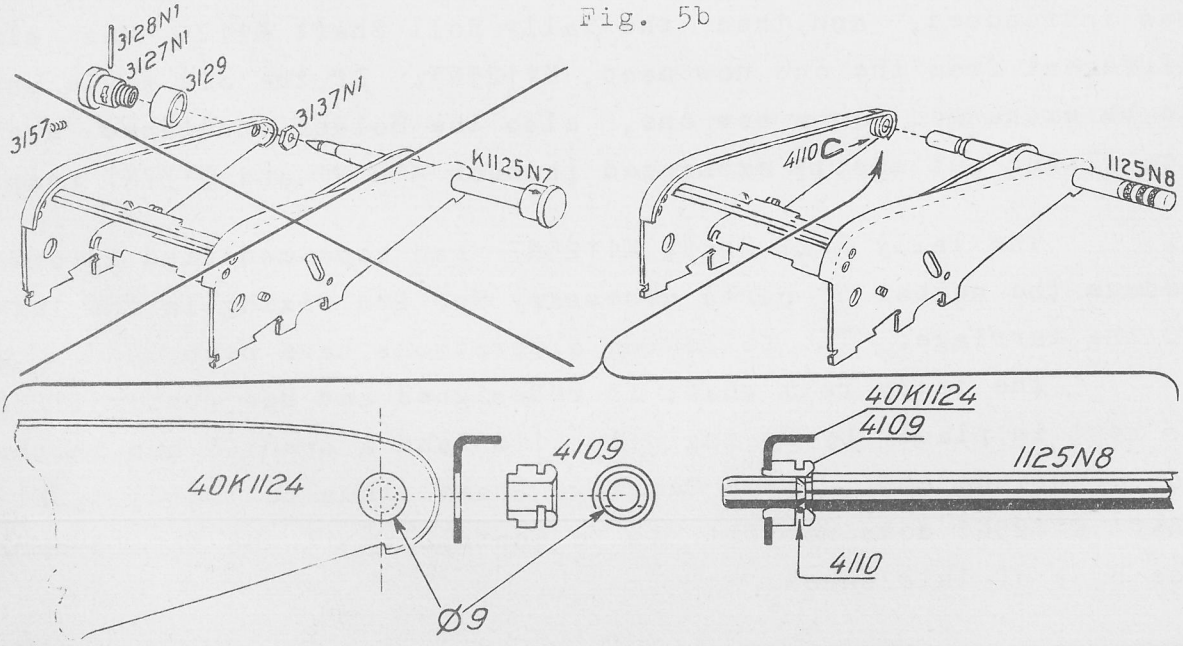
Fig. 5b

Tally Roll Shaft 1125N8 can be used on older carriages if Hub 4109 is riveted to the left hand carriage end. Put the shaft in place before attaching Spring Clip 4110.

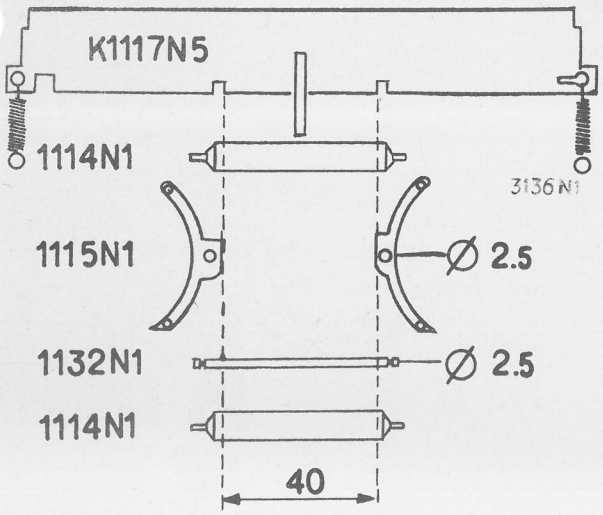
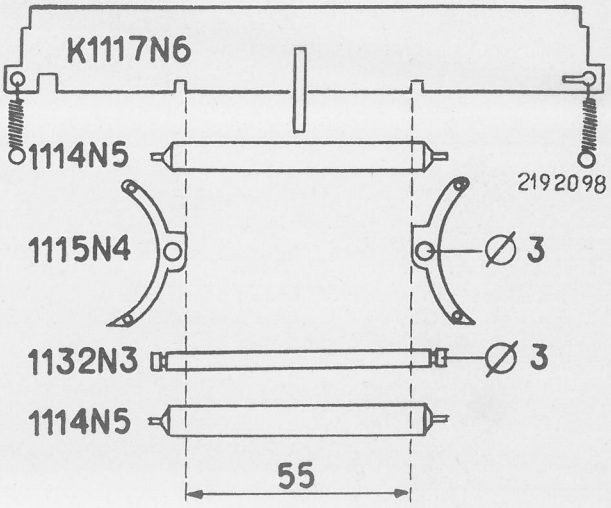
Fig. 5c

The figure to the left is showing the paper feed rollers hitherto used, the right hand figure showing the new rollers and holders which can also be installed in older machines.

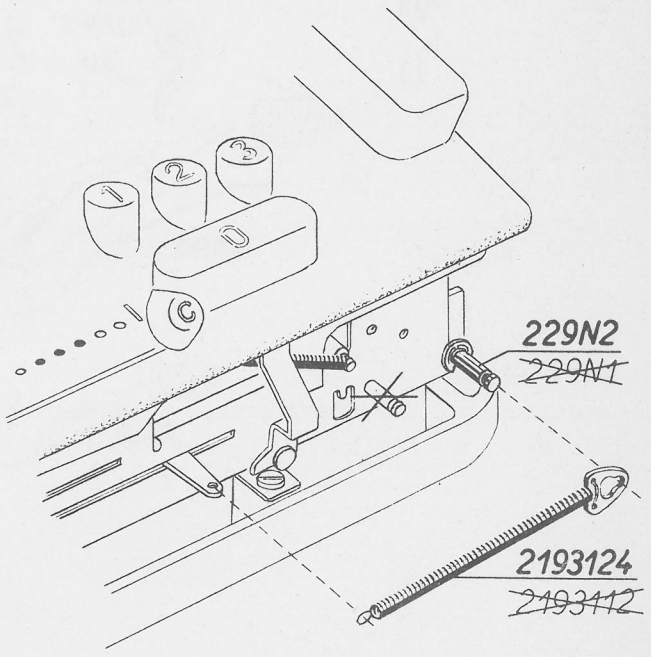
Fig.13

In order that the step lever should have as uniform a spring load as possible we made a new and longer key board front spring. This new spring, which is number 2193124, is anchored on Shaft 229N2 as shown in fig. 13.

When replacing the formerly used spring 2193112 by the new one 2193124, also Shaft 229N1 must be replaced by 229N2, and the spring stud removed.

Machines coming from the assembly line after July, 1955 are equipped with Spring 2193124.

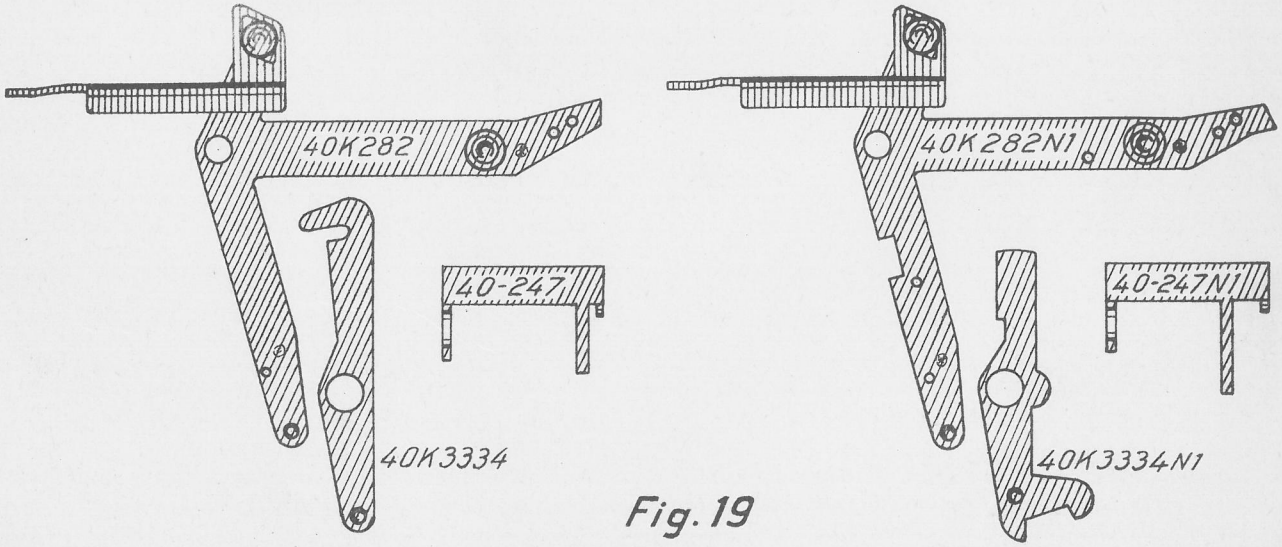
Fig. 19

6. Due to a mistake there have been put faulty Stop Carriage Buffers 40-3325 into a number of machines. The fault may cause the same misfunction as is described in "3", so you are advised to control the part in question when overhauling machines.

7. As the way of fixing the key board on the base plate shall be altered, the Blocking Bridge 40-247 has already been made the object of a modification. Until the alteration is completely carried out, a special Blocking Bridge Catch 40K3334N1 and a special Step Lever 40K282N1 will have to be used with the modified Blocking Bridge 40-247N1. The parts in question are all illustrated below.

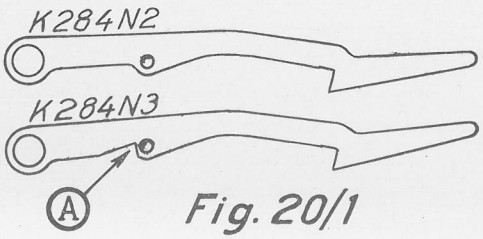
Fig. 20/1

When assembling the key board of electrical machines equipped with the new Key Board Fixing Shaft 1098 it will be necessary to control that Return Step Hook K284E is filed ff to allow Spring 283E

to be attached with the coil pointing towards the key board bottom. [The part should look like K284N3]. If the Spring is installed otherwise it will be squeezed between the fixing shaft and the return step hook. The stud for attaching the spring will be moved within short to avoid the trouble. [Page 222 of the Spare Parts List].

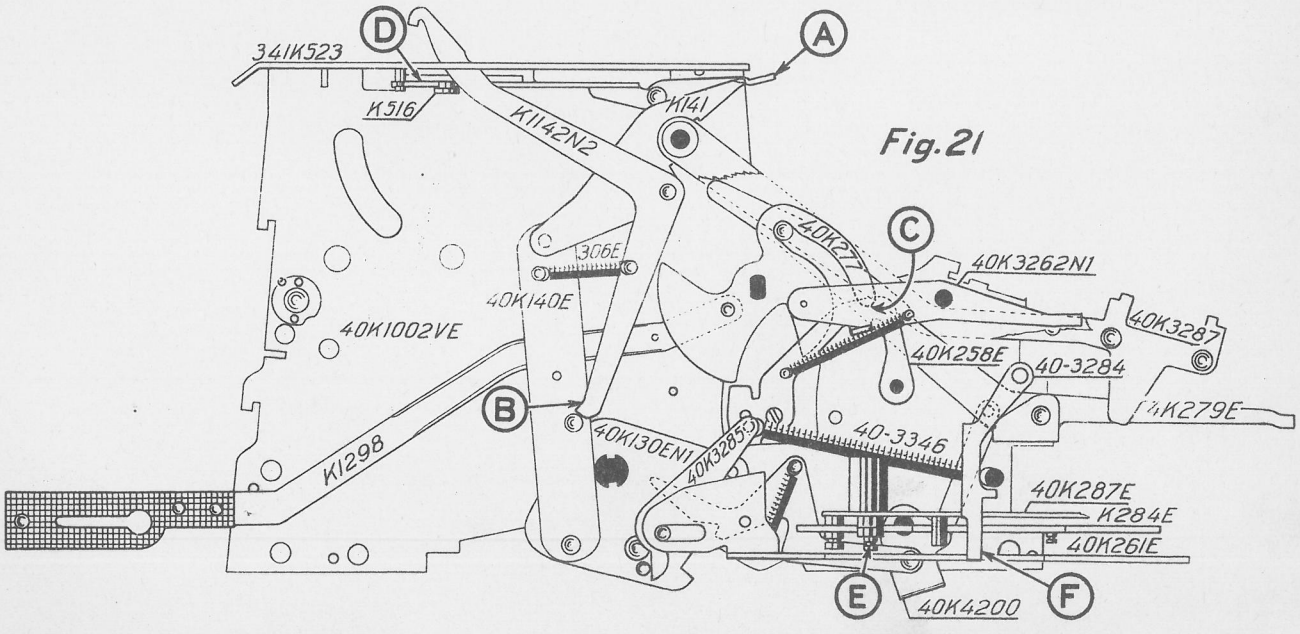
Fig. 21

Note the projection C of part K277, espacially on old machines. If it has a tendency of hitting the stud of part 40K3262N1 it should be filed off for free movement.

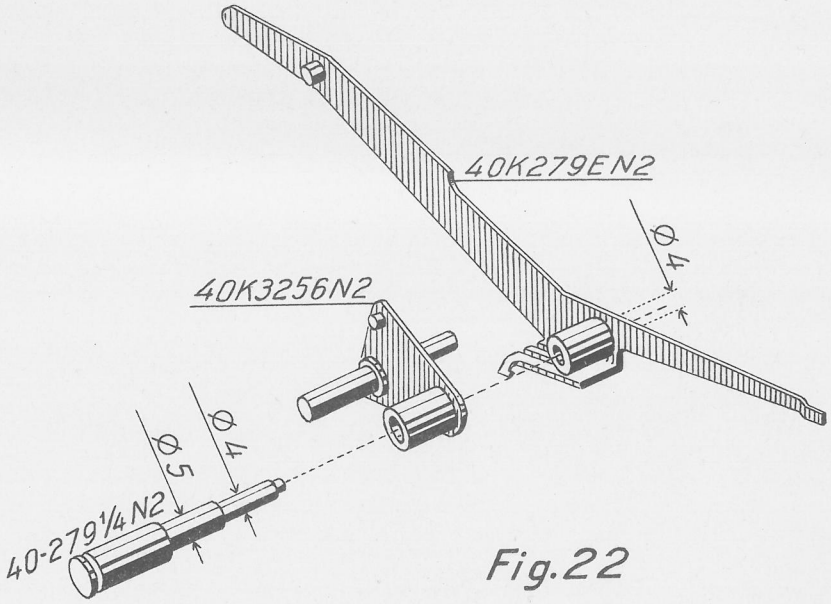
Fig.22

The bearing of the Total Locking Lever has been modified in order to make the part more rigid. Then the Starting Bridge Actuator and Shaft 40-279¼N1 were slightly modified too, and the new numbers are: 40K279EN2, 40K3256N2, and 40-279¼N2 respectively. The modified parts, illustrated below, cannot replace the formerly used parts independently.

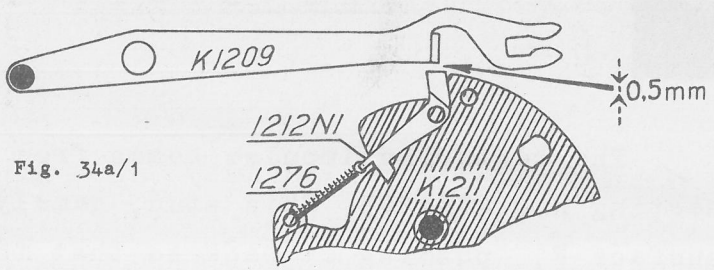
Fig. 34a/1

Adjust the Starting Lever K1207 as per the above figure, which illustrates the parts after the motor key has been depressed. Then the play between K1209 and 1212N1 should be .5 mm. Adjust on the Contact Bridge K1246.

G. The play between the Starting Lever K1209 and the ratchet must not exceed .5 mm after any motor key has been depressed. See Fig. 34a/1.

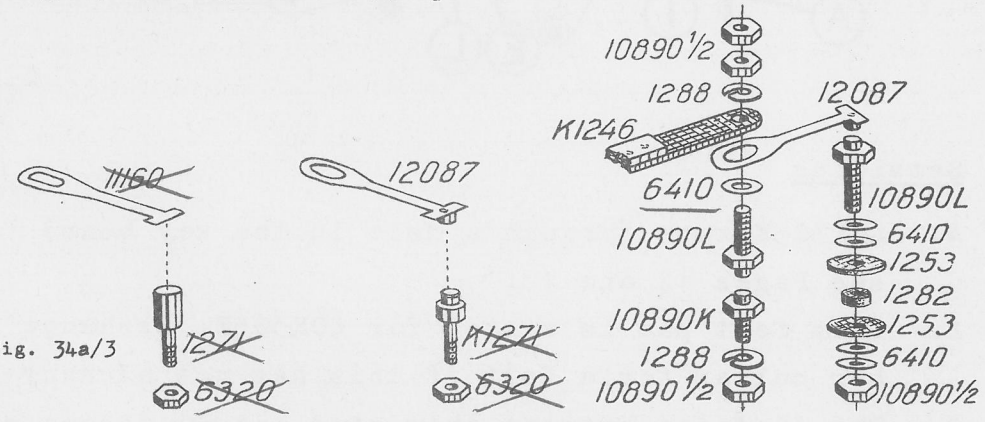
Fig. 34a/3

Experience has shown that the spring hitherto used on the contact bridge is a little too weak. Therefore, it was replaced by a special Spring 4300. [March 1951].

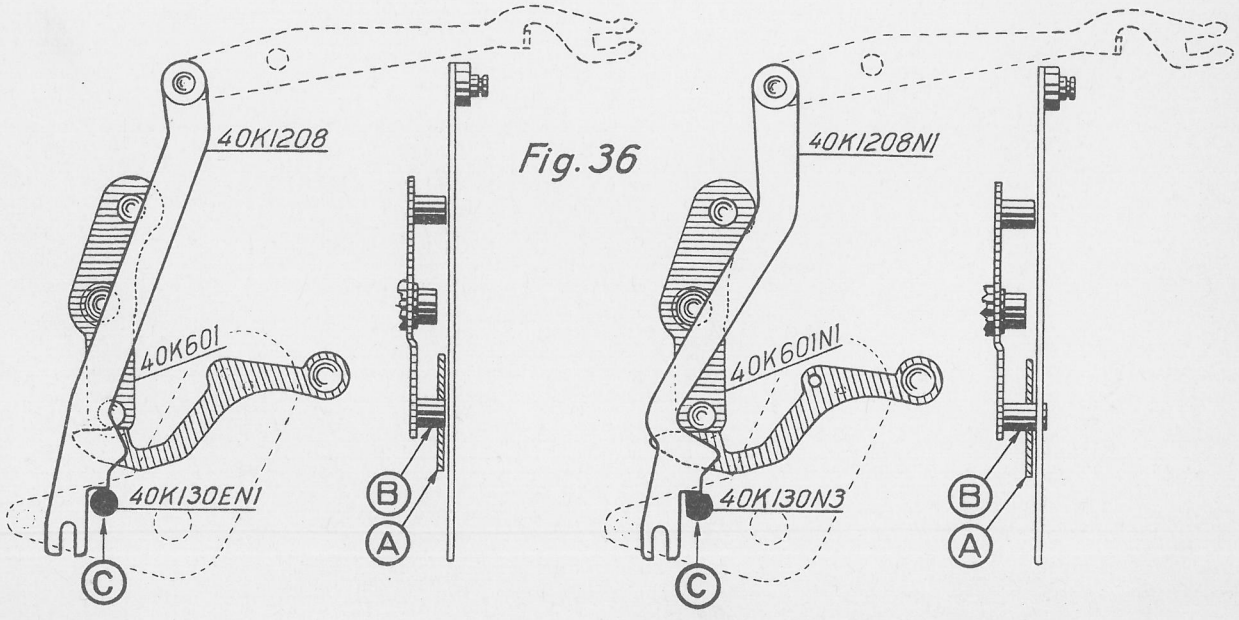
Fig. 36

3. The stud "B" of the Centre Shaft 40K601 has been lengthened in order to provide better engagement with the latch "A". At the same time the latch was modified as per Fig. 36.

Of the parts mentioned only the Totalizer Coupling 40K806E with the new latch can be used on old machines. The other parts have got N-numbers as they cannot be used on machines manufactured before the modification was put into production.

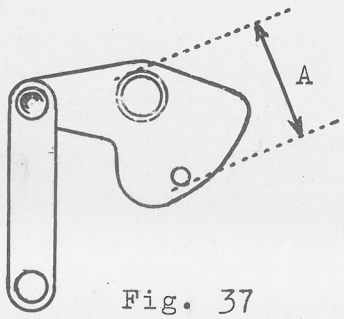
Fig. 37

4. To provide better engagement the Start Lever 40K4204 has been slightly modified as regards the studs. The modified part has number 40K4204N1, and it cannot be used on machines prior to: 341EC - A85084, 341E - A86717, 41E - A86272 and 40E - A86900.

On 40K4204 the distance A is 14.5 mm; on 40K4204N1, 13 mm.

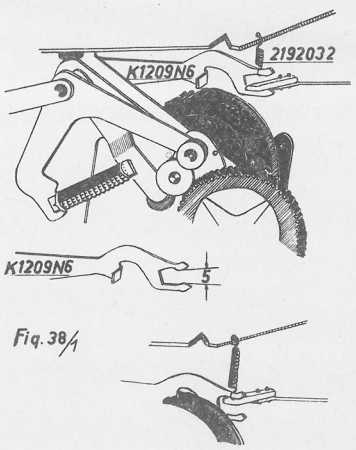
Fig. 38/1

Widen the fork of Part K1209 to 5 mm.

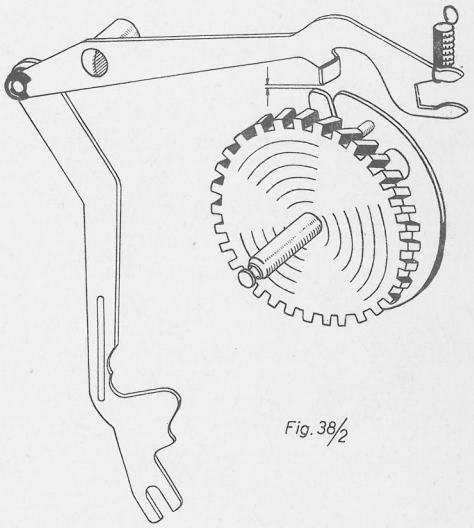
Fig. 38/2

Put on Spring 2192032 between the fork and the Top Plate.

Set a distance of .5 mm [machine started] by forming the Contact Arm.

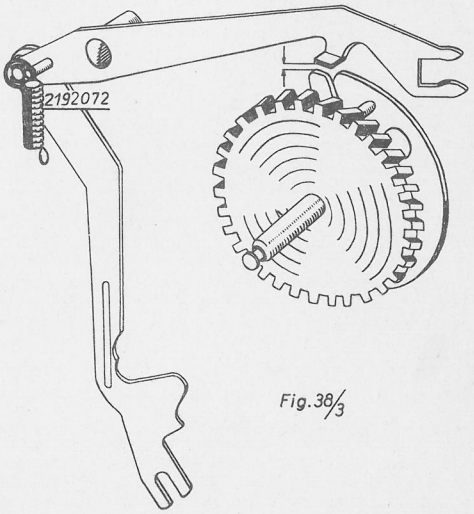
Recently manufactured machines are equipped with modified Start Arm and Spring 2192072. Do not install Spring 2192032 on such machines. Contact Arm to be adjusted so that a distance of approximately 1.5 mm between contact points is maintained.

In machines where the spring for part K1209 is so positioned as shown in Fig. 38/3 it is not advisable to install the double balance spring. The proper spring to be used on such machines is one with Part Number 2193807. This spring should be installed between the stud of the right hand driving segment and the short rod of the bearing plate, close to the bearing of the Starting Ratchet Wheel.

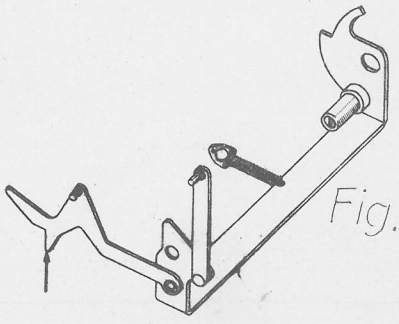
Fig.39/4

Let the machine make about twenty repeat strokes under power and pull out the plug KEEPING THE REPEAT KEY DEPRESSED. Check if the starting ratchet has retained its position in relation to the wheel. If it has not, shorten the lug [Fig. 39/4] a trifle where the arrow points [lower edge]. Check again as per above. When you have reached the point where the starting ratchet does not disengage during operation [check with various number combinations] stop filing, and install the Balance Spring 2192993 or 2192807. [See Page 142 X.]

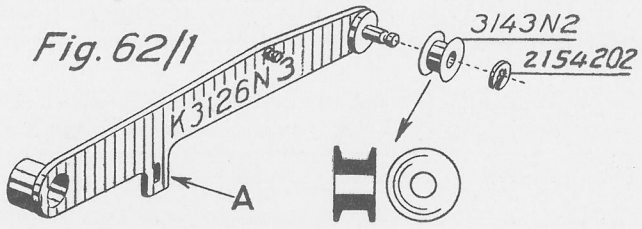
Fig. 62/1

The first machines of the 40-series were equipped with Print Hammer Frames that have riveted distance pins instead of pressed lugs. When installing K3126N3 and K3126N4 in such machines it will be necessary to file the extension "A" for free movement.

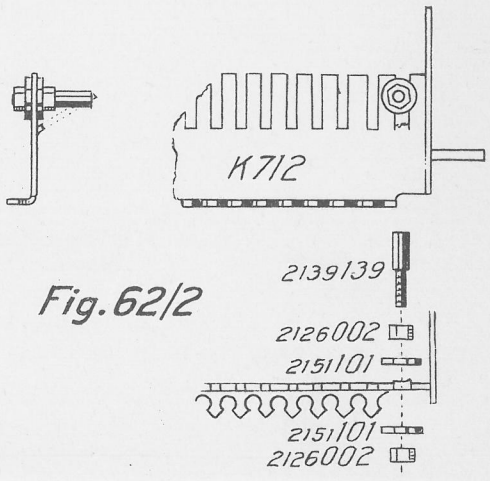
Fig. 62/2

2. It has proved that the Ribbon Guide Control Lug of the Print Hammer Frame K712 (different N-numbers) does not stand too much adjusting. Now, in case this lug breaks off you can remedy the machine by fixing the threaded pin 2139139 in the slot as shown in Fig. 62/2. The Tool R340 will help you to do this without removing anything but the cover and carriage of the machine. The pin should be so positioned that the ribbon guide cannot slip off. Also check after installing that the print hammers move freely in their slots and that the type bars are not prevented from printing. The Tool R340 also can be used when adjusting the outer nuts of the governor of the motor.

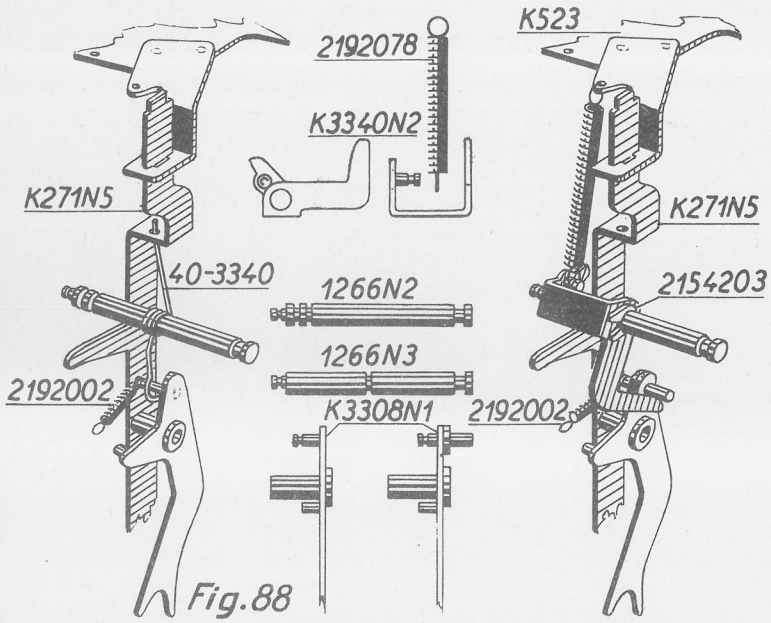
Fig.88

Twist Spring 40-3340 required too much adjustments, and has been superseded by the construction shown in Fig. 88. It consists of a Lifting Arm Retainer 40K3340, kept in position on a new Shaft 40-1266 by Spring Clip 1013, and a Spring 300-9300. The parts can be used on older machines if Lifting Arm 40K3308 is exchanged for a new one with a double pin.

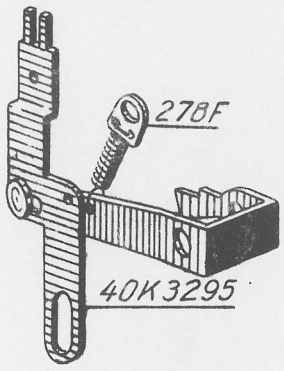
Fig. 91/2

Fig. 91/1 shows the first type of total and sub total keys that was used on the 40 series. However, in order to improve the guiding of the keys they were modified to the shape shown in Fig. 91/2. New style keys can replace the old ones if Spring 931 is exchanged for 8640 at the same time.

In machines with this spring clip Sub-Total Key K3298N1 is carried by its shaft directly without bushing, which means that the hole "A" is smaller than before, see Fig. 91/1 and 91/2. The bearing of 40K3300N1 has been shortened, as it shall only carry the start balance blocker.

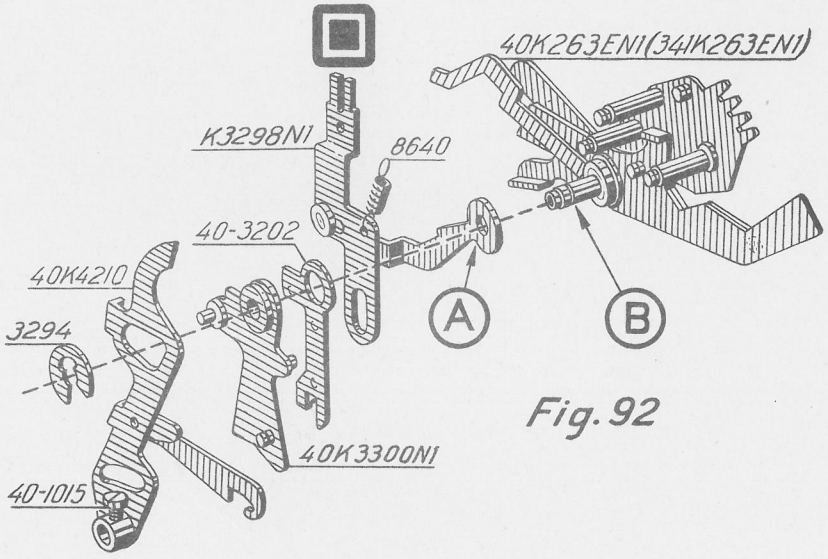
Fig. 92

Machines with numbers above those mentioned thus have a Spring Clip 3294 [Fig. 92] in the groove "B", limiting the lateral play of the parts. What caused this modification was the fact that the Start Balance Blocker 40-3302 could come at the side of the stop lug of the Start Balance 40K4210 thus failing to stop it. See Fig. 33.

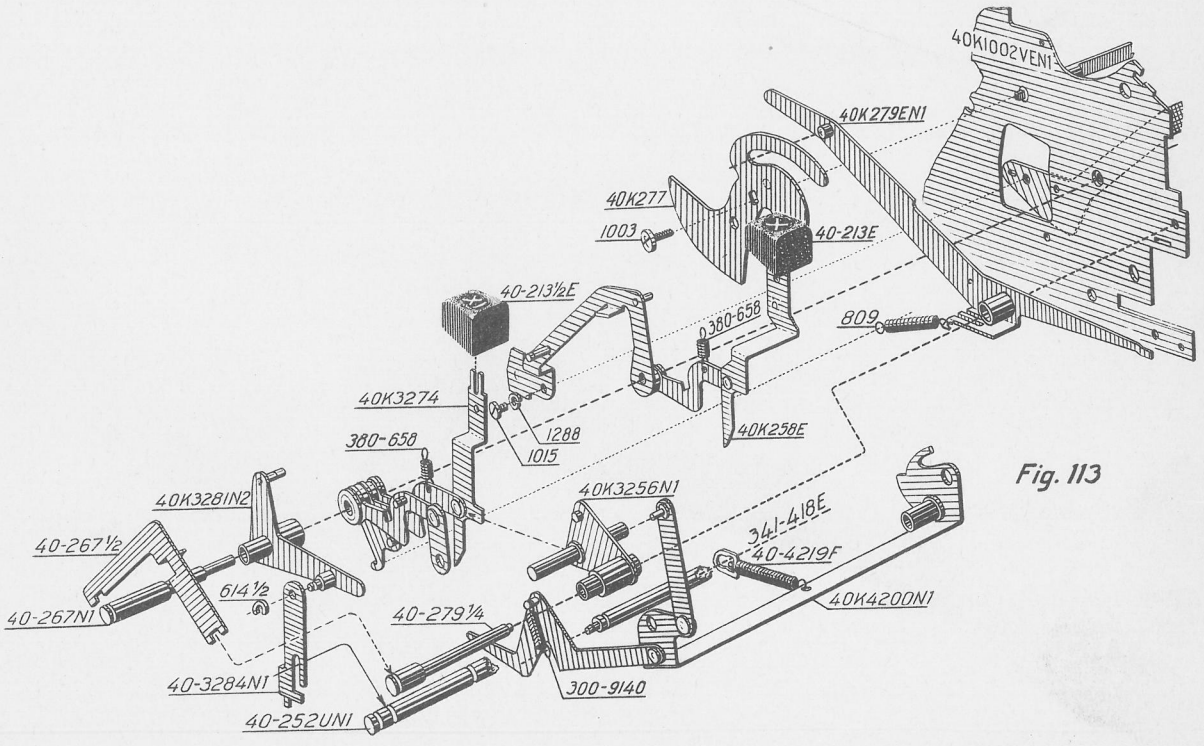
Fig. 113

Shafts 40-267N1 and 40-279¼N1 [number wrong on Fig. 113] are locked laterally by Locking Knee 40-267½. On this part there is a lug which should prevent the repeat stem from jumping up and getting blocked on the key board. However, on some machines there is locking knee without this lug. Such parts should be exchanged for new ones.

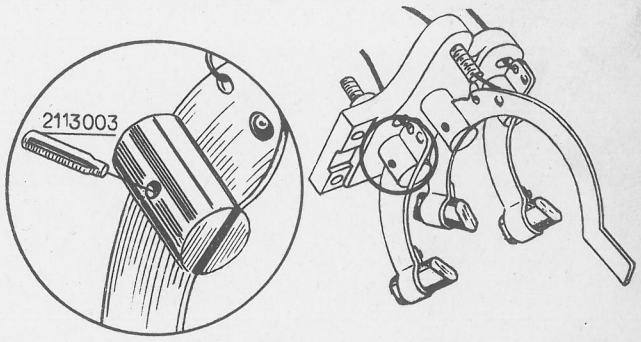
Fig 116/2

In order to avoid excessive wearing of the brush holder bearings we are now using Slotted Pins 2113003 as fulcrum instead of the hitherto used tubular pins. Worn brush holder bearings can break the current and stop the machine. The brush holders are numbered as follows:

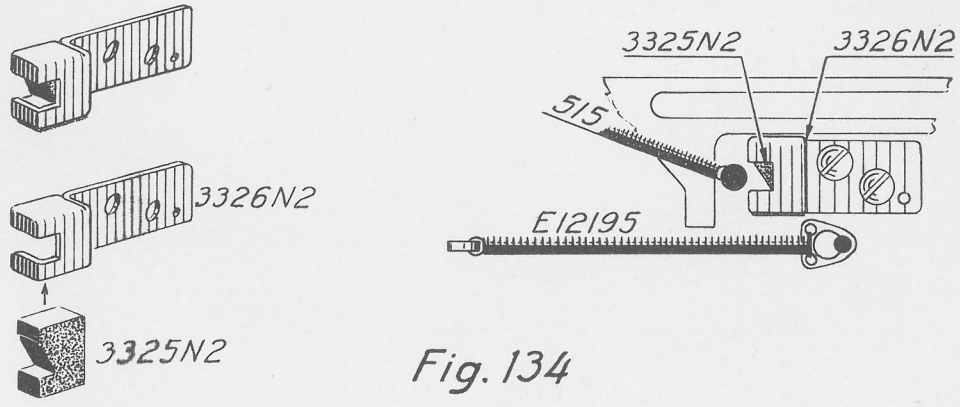
Fig. 134

When manipulating the keys in a certain way it is possible to get the wrong number in the beginning of an item set on the key board. This can possibly happen, if a numerical key is depressed when the stop carriage is returning and stopping against the buffer. Any stop-pin can then jump up and cause the indicated misfunction.

To avoid this trouble we bevelled the stop-surface of the buffer, so that the stop carriage does not vibrate at the end of its restoring movement. The recoil was made smoother by exchanging Spring 40-3344 for E12195. The latter spring is delivered free of charge as replacement for 40-3344. A roof also has been provided on the buffer holder, so as to fix the position of the rubber piece.

If wrong number should enter in spite of adjustment being made as per the above instructions you are advised to install Spring 7680½ in the Escapement Bracket 40K230E [=K230N6], and in extraordinarity difficult cases

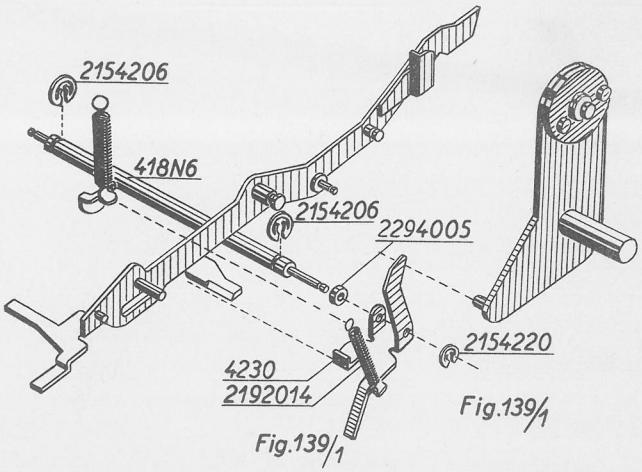
Fig.139/1

Machine jamming on Total

Depressing Total Key at the right (wrong) moment after multiplying with step-over can under circumstances obstruct certain machines. The cause of this is the Blocking Bridge 247N2 interfering with the stop carriage teeth before the stop carriage has reached its right position. However, this is avoided positively if Start Detainer 4230 is installed on Shaft 418N6 (on machines with Credit Balance: 418N7). The detainer keeps part 305 from starting, until released by a stud of the main shaft. When installing the new detaining arrangement as per Fig. 139/1 the following parts will be required:

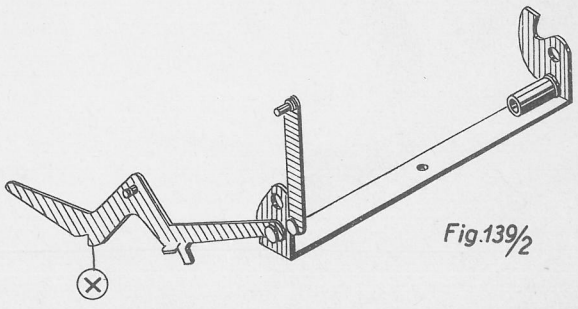
Fig.139/2

If the machine prints a lower figure than set on the key board when multiplying with step-o-matic lever in off position, the Starting Lever K1209 is probably hitting the Starting Ratchet 1212 during operation. The machine is thus disengaged from the motor (and speed governor) for a short period and runs ahead of the motor at a temporarily increased speed.

Do the following check: Remove the Balance Spring 2192993 if there is one, disconnect the power, set the step-o-matic lever in off position, depress the multiplication key, actuate the machine by hand until the starting ratchet engages in the starting ratchet wheel, mark the position of the ratchet on the wheel, and let the machine run under power about twenty revolutions in multiplication. Then disconnect the power again but KEEP THE REPEAT KEY DEPRESSED, and observe if the ratchet wheel has retained its position in relation to the ratchet. If it has not, the Starting Bridge K4200 must be adjusted for an earlier start, and this is done by shortening the lug (at X, Fig. 139/2) of the restoring lever, just a trifle. Then check again as described above. Be careful not to shorten the lug more than is absolutely necessary to prevent the starting ratchet from disengaging during operation. After a perfect adjustment as per above, the Balance Spring 2192993 is no longer necessary. THIS ADJUSTMENT SHOULD NOT BE DONE UNLESS THE MACHINE IS EQUIPPED WITH START DETAINER 4230 AS PER PREVIOUS PARAGRAPH.

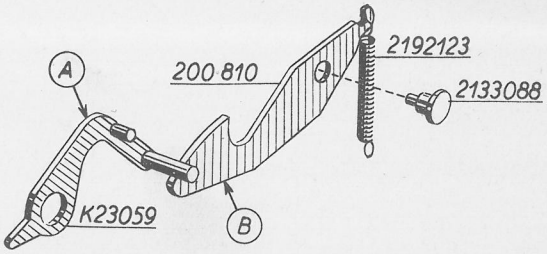
1. Totalizer Coupling Adjustment.

We have had a few cases where the machine has blocked up because the lower outer dog of the Totalizer Coupling has come above the stud of part K23059 in Sub-Total out of the second Totalizer. This dog (B) should go under the stud, and to insure correct function at this point, it may be necessary to form the stud rearwards, in over the dog. When doing so, you are recommended to support Part K23059 by inserting a screwdriver at "A" between the part and the side frame.

If a machine blocks up as described above, the Totalizer Coupling is likely to get bent. The most safe repair in such a case is to install a new coupling. However, you may not have this part in stock, and then you will have to dress the bent one very carefully. If so, note that the outer contours of the two members should cover each other closely. It is advisable to lengthen the dog a little for better engagement on the stud at the same time. You can also remove the dog entirely and use a new and longer dog. Such dogs, and rivets are available as spare parts under the Parts Numbers indicated in fig.

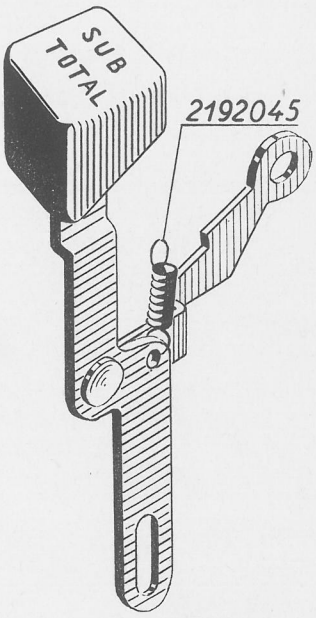
A stronger spring is now used to keep the Sub-Total Key in rest, or inactive, position. We made this modification, because an operator could, through hitting the Total Key violently, engage the Sub-Total Mechanism, and make the machine behave as if the Sub-Total Key had been depressed.

The stronger spring has Spare Part Number 2192045, and it has been installed here at the factory on all 200-class machines bearing a Serial Number higher than 525028. If machines with a lower number give you trouble in this respect, reject the formerly recommended Spring 2192032 and install 2192045 instead.

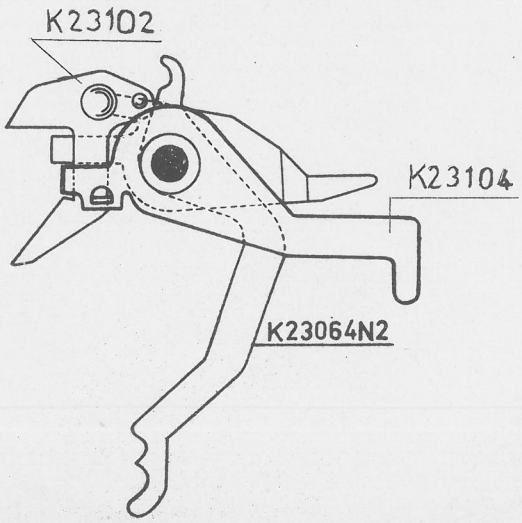
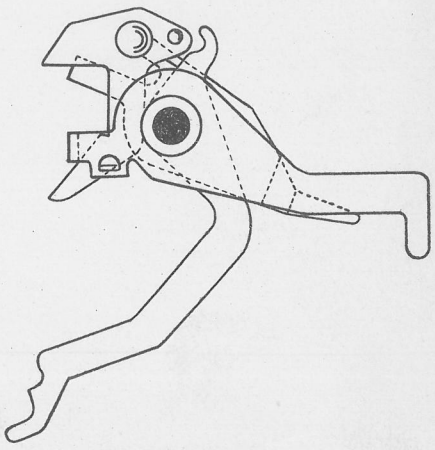
Cause of the trouble: This kind of trouble may be caused by a bind in Part K23104. If there is a bind, namely, Part K23104 may remain in set position, i.e. the position it has during a Sub-Total stroke. This position is shown in the right hand figure below. Note that Part K23102 will not actuate the latch when rotating into active position for Total.

The left hand fig. shows correct initial position of both parts. When K23102 rotates into Total position it takes K23104 with it, which it should.

A bind like this may appear in machines manufactured before October 1956, because in such machines there is nothing the hold the shaft, on which the two parts in question are fulcrumed, in position sideways. Consequently, the shaft can move sideways and jam the parts against the side frame.

Repair: In machines manufactured after September 1956 the parts K23064N2, K23104 and K23102 are fulcrumed on a Bushing 2155108 which guarantees free movement. The shaft then can jam the bushing, but never the parts on the bushing. The repair will be to install the modifed parts and the bushing. (The bushing has an outer diameter of 6 mm, and the only modification made to the K23104 and K23064N2 is an enlarging of the bearing holes).

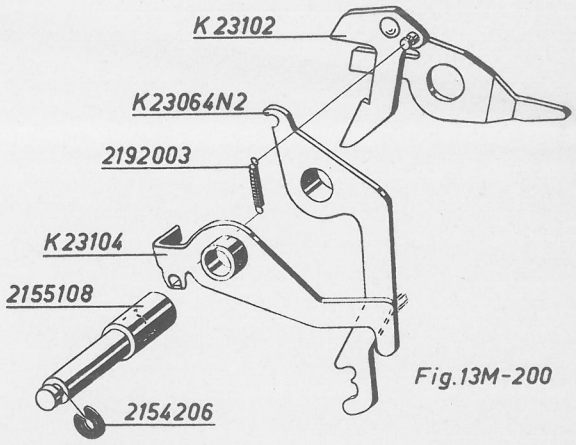
Fig.13M-200

If a Total from the 1st Totalizer fails to enter the 2nd Totalizer we get underaddition as a result. This has happened in a few cases, and in these cases the Total was always taken directly after a Sub-Total.
